Subject: RE: Arrow Field Services, LLC Bear Den Gas Plant - tank emissions video

The North Dakota Department of Environmental Quality, Division of Air Quality (Department) met with Fielding Lewis and Donald Fuller of Crestwood Equity Partners, LP (Crestwood) on September 16th, 2019 at approximately 4:45 pm CDT at the Bear Den Gas Plant. I discussed my concerns with them regarding initially being told that there was no issue with any tanks at the Bear Den Gas Plant and then being informed that there was an issue causing the automated dump valve from the slop separator to stick in the open position on August 22nd.

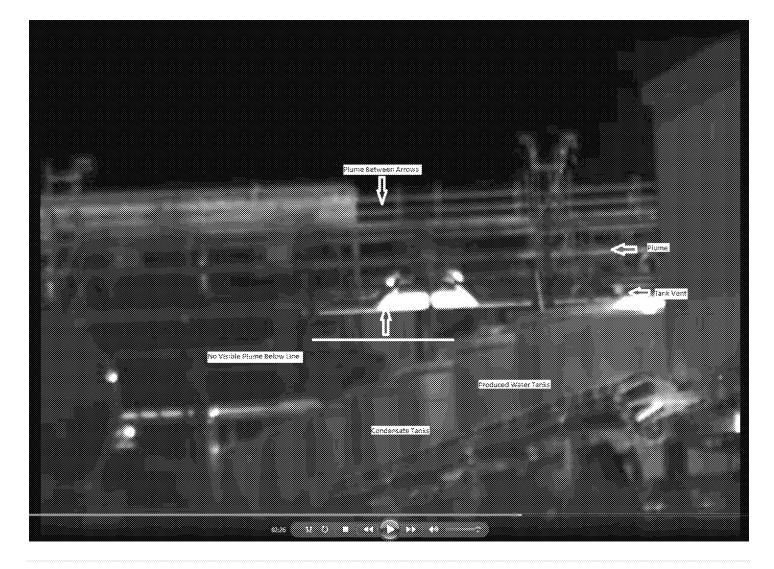
Regarding the condensate tank enardo ABV included on the DOR list; these records were reviewed as well as additional information. The concentration of the leak on the report is included as 2,382 ppm, a concentration that is generally not visible from the distance of 300 ft. An inquiry was sent to the LDAR contractor about this leak, their response was (emphasis added) "[t]he probability of picking up on a 2,400 ppm leak from 300 ft away is next to zero. A leak at that level would need to be inspected from less than 6 feet away with the ideal thermal contrasts. [...] I agree with you, it is apparent that the emissions are coming from the produced water tanks. A leak at 2400 ppm from the condensate tank would not be visible from the road." Based on the vendor's expertise, citing the enardo ABV that is on the delay of repair list as the source of the plume would have been misleading. As clarified in the email and photo sent September 3rd the primary source of emissions that are visible are from the tank closest to the viewer in the tank battery, which is not a condensate tank.

Additional details are included on the photo below, showing the condensate tanks are well below the visible plume from the produced water tank. Condensate tanks are the third and fourth tanks from the viewer, there is no visible plume from these tanks in the video as the roof of the condensate tanks are well below the plume. In other words, emissions from an enardo valve would be visible directly from the roof of these tanks and not masked by the plume from the produced water tank. Other sources or contributing factors to the plume were also considered and excluded from the written response because it would not have been accurate.

In response to your request, the enardo ABV on the condensate tank was repaired last week. Please let me know when you would like to visit the site to inspect the valve and walk down Phase 2. Note that I plan to attend if possible.
